October 18, 2018

Re: Briggs Mill Dam Inspection Summary and Preliminary Dam Repair Recommendations

Attachment A: August 2018 Field Photographs

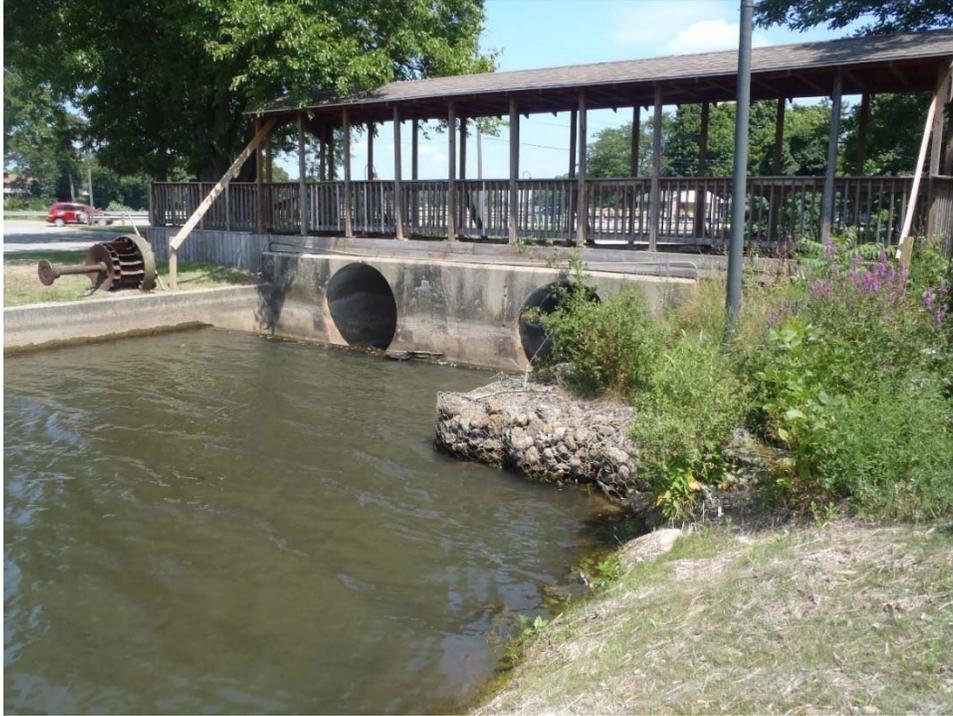
The spill tube structure is a concrete structure with two 6-foot diameter corrugated metal pipes (CMP) passing through the concrete. Upstream of the concrete structure is a containment pit and a concrete wall which acts as a weir (Photo 1). When the reservoir water is higher than the top of weir elevation, water passes over the weir and flows out the spill tubes. The weir and footings (approximately 1 foot upstream and downstream of the weir) were installed in the spring of 2018. A covered walkway extends across the top of the spill tube structure. The downstream side consists of an angled concrete face and a left wing wall (Photo 2).

The upstream retaining walls on both sides of the spill tube structure were observed to be in good condition, as visible above the water level (Photo 18). The weir also was observed to be in good condition. The containment pit had a concrete bottom, but the area upstream of the weir was covered in rocks.

Photo 1 Spill Tube Structure, upstream side

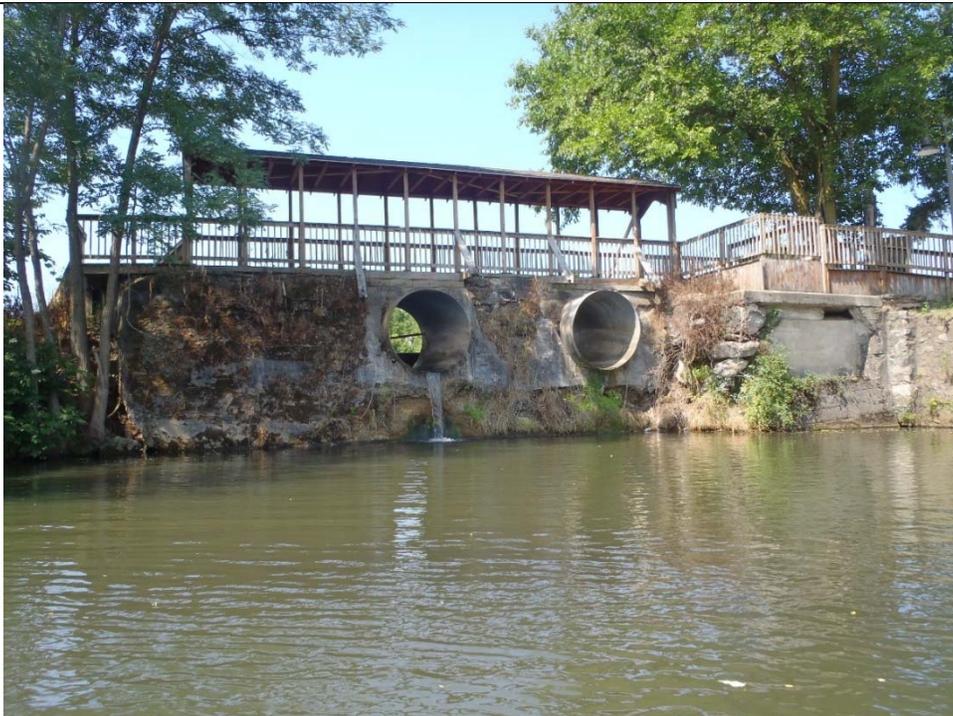
Photo 2 Spill Tube Structure, downstream

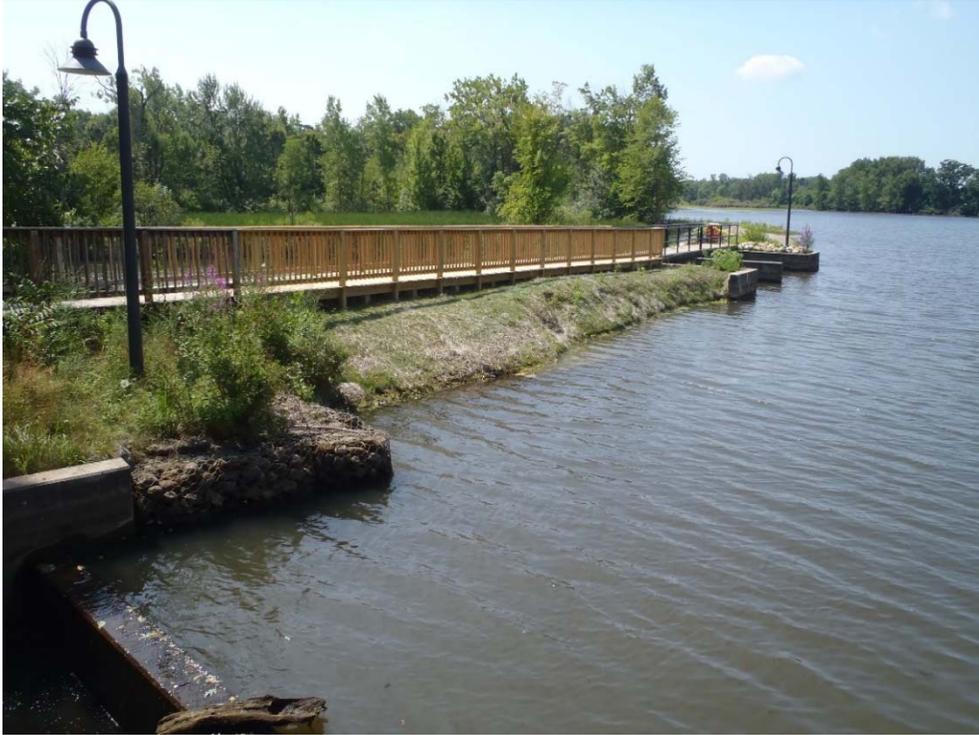
The earth embankment extends between the spill tube structure and control structure (Photo 3). The embankment breached along the left abutment of the control structure during a storm event in October 2017 and was rebuilt in the spring of 2018. Embankment soils are assumed to consist of sandy clay based on field observations and is covered with vegetation. The downstream side of the embankment, adjacent to the control structure where the breach occurred, was repaired with riprap (nominal 12 inch diameter fieldstone) while the rest of the downstream side is covered in vegetation (Photo 4). The

Photo 3 Earth Embankment, upstream

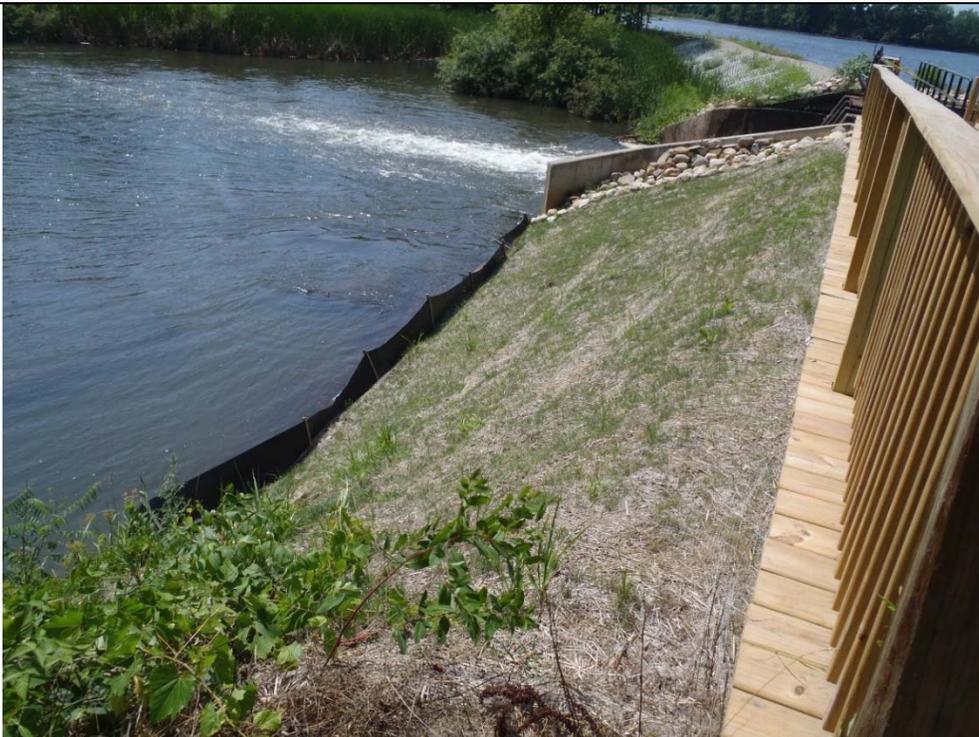
Photo 4 Earth Embankment, downstream

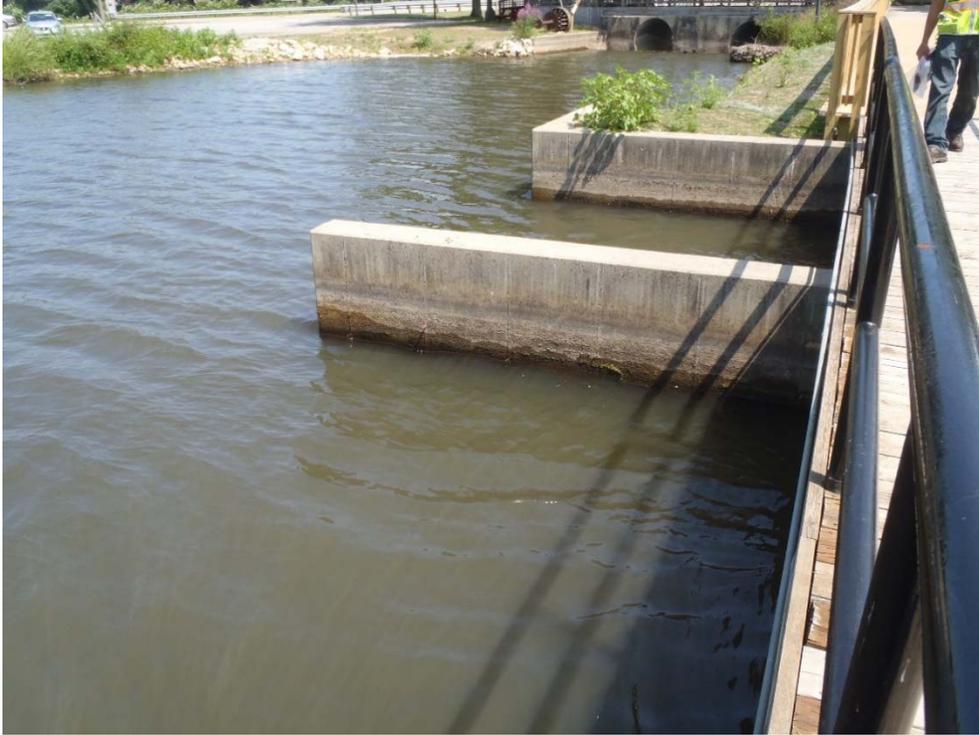
The control structure is a reinforced concrete structure extending between the earth embankment and the emergency spillway and consists of five bays for flow passage (Photo 5 and Photo 6). The middle bay has a deeper sill and can be adjusted for flow using a gate. Gates can be installed in all bays.

Photo 5 Control Structure, upstream

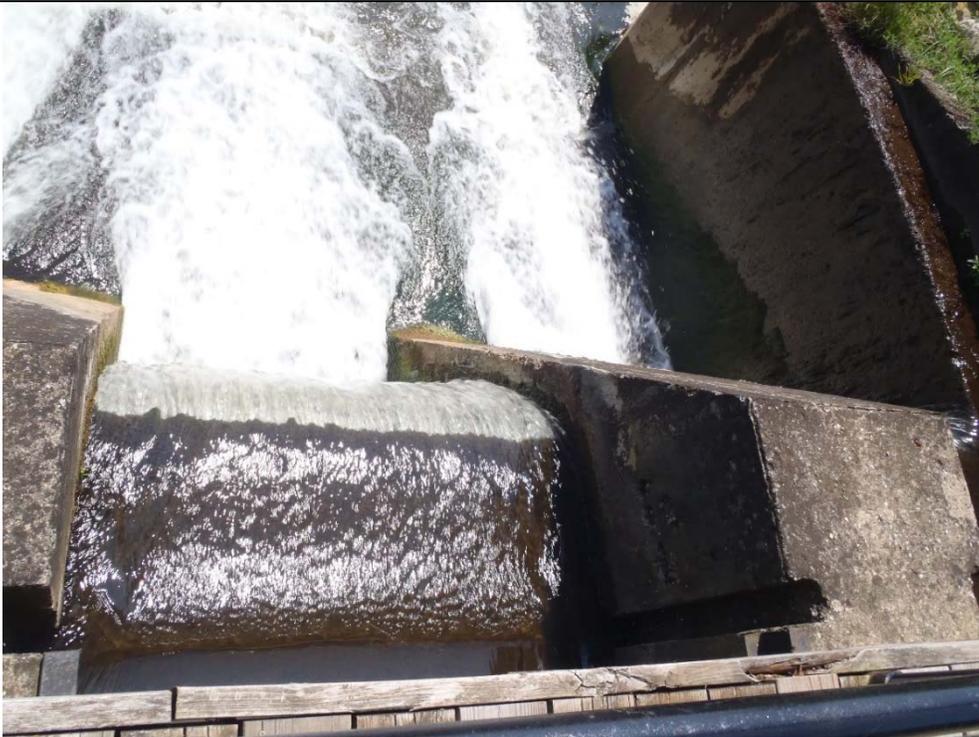
Photo 6 Control Structure, downstream

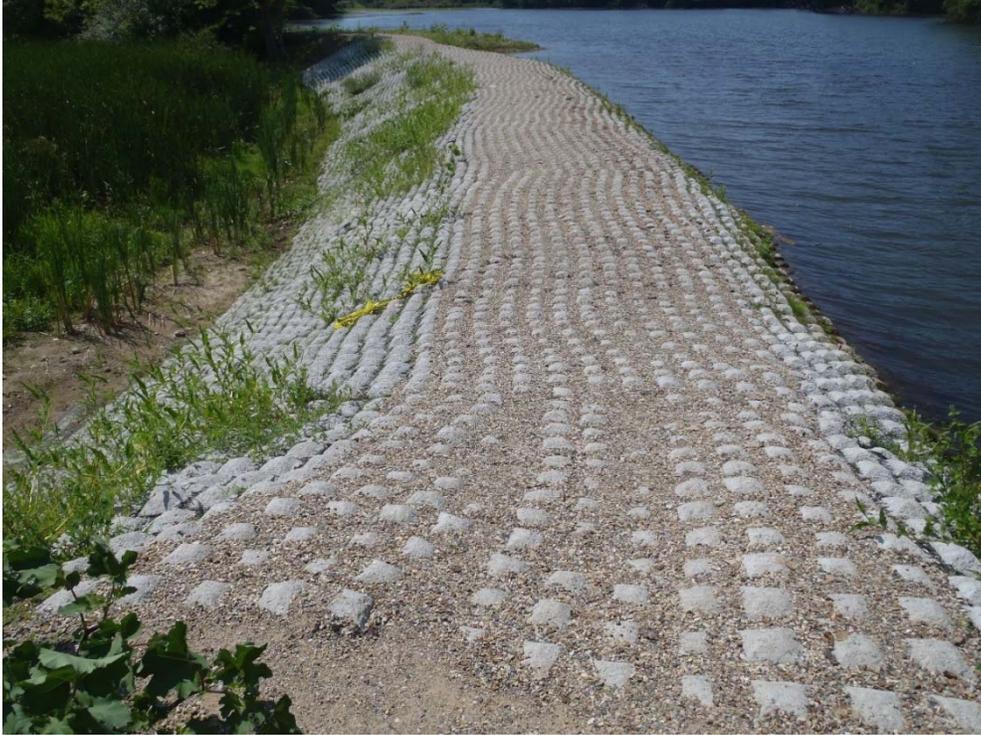
The emergency spillway crest is approximately 2 to 2.5 feet lower than the crest of the adjacent control structure and earth embankment. The emergency spillway consists of an earthen embankment covered with geotextile fabric and articulated concrete block (ACB) (Photo 7). This spillway was built in the spring of 2018.

Photo 7 Emergency Spillway

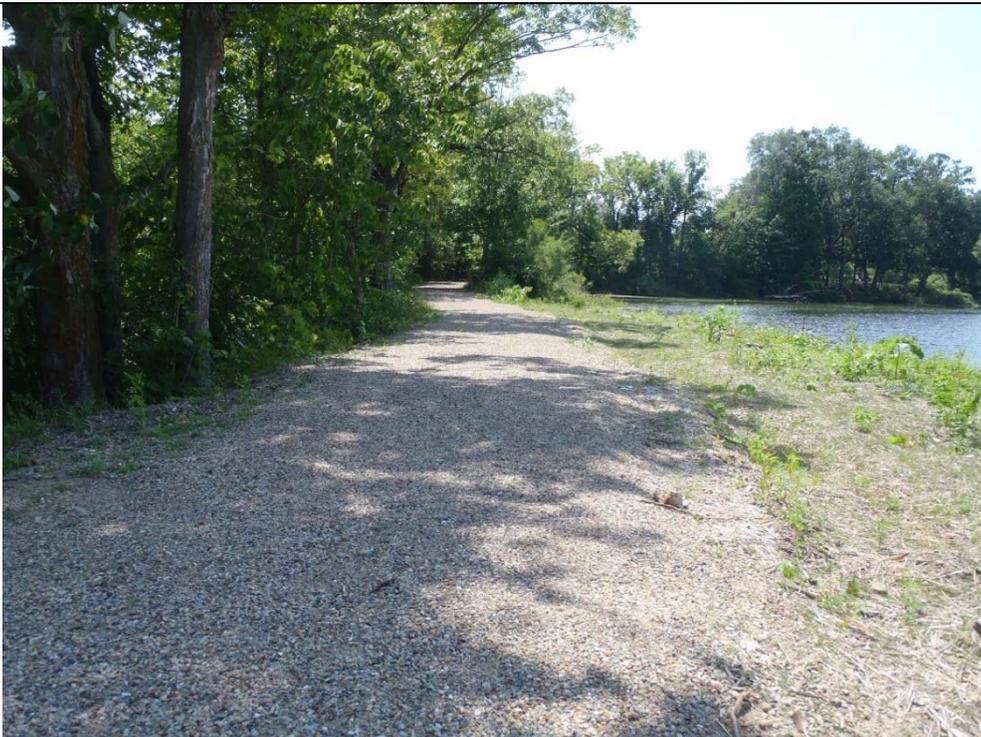
South of the emergency spillway is an earth embankment with a walkway across the crest (Photo 8).

Photo 8 Southern Earth Embankment

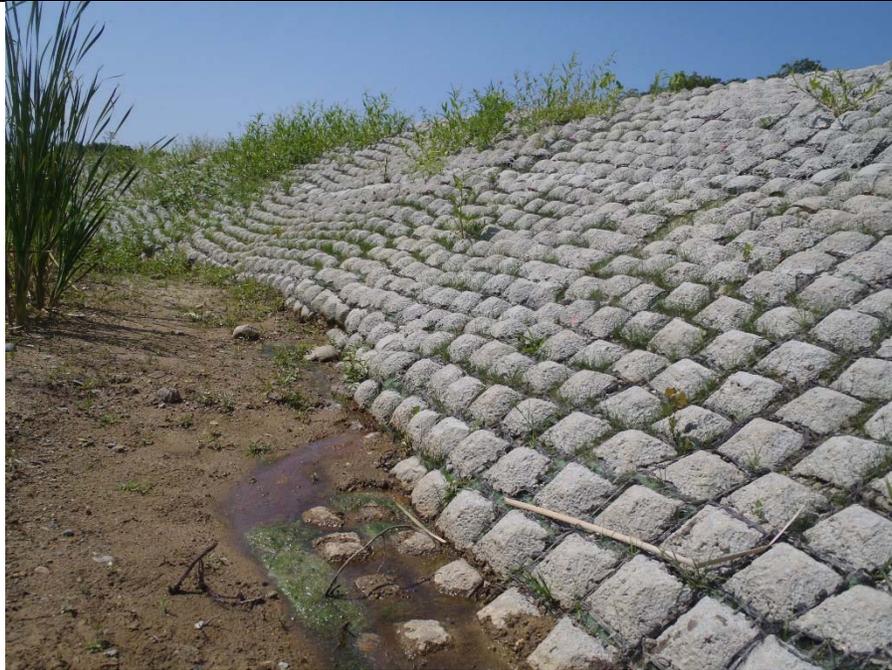
The emergency spillway is starting to grow vegetation and seepage was observed on the downstream side, approximately 10 feet from the right edge of the control structure. According to John, this is a

Photo 9 Seepage on Downstream side of Emergency Spillway

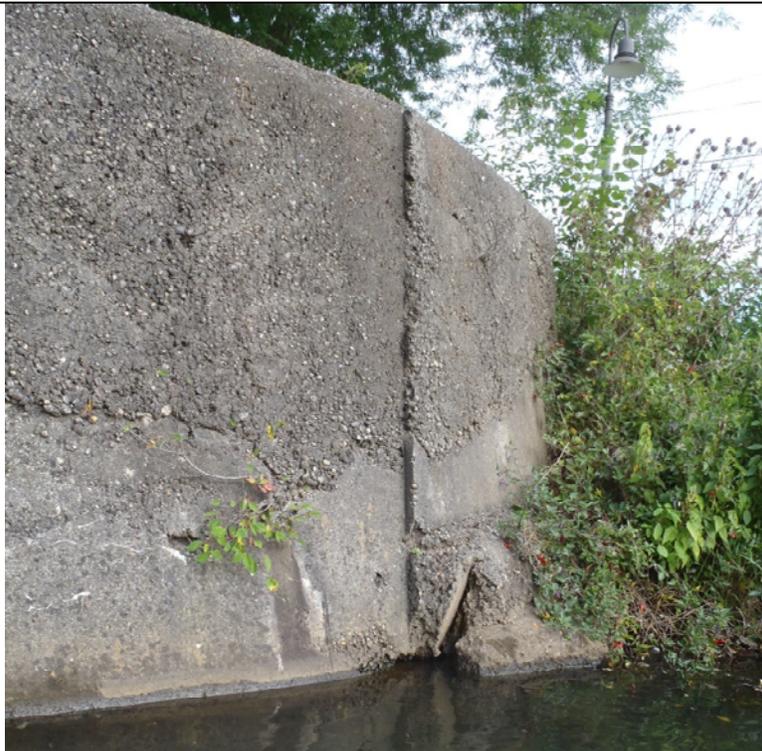
The spill tube structure was inspected from a boat on the downstream side and visually from the upstream side. On the downstream side, the left abutment wall that extends downstream consists of a grouted cobblestone wall on the upstream 15-20 feet and an asphalt overlay downstream. The asphalt had exposed aggregate (Photo 10) and was deteriorating on at the base at both the upstream and downstream sides. It appears the asphalt was placed on the embankment surface to create a curb to re-direct surface water flow. Also, there was significant deterioration, visible soil, and loss of cobblestones and grout where the aggregate section connects to the grouted cobblestone wall (Photo 11). The area of deterioration was approximately 4.5 feet wide at the top, 8 feet high and 1-1.5 feet deep. Vegetation was growing throughout. The grout between the cobblestones was deteriorated in many locations, damp due to seepage, and crumbled when hit with a hammer. The upstream 10 feet of the cobblestone wall was observed to be in better condition. No depressions or signs of seepage or soil loss were noted on the soil adjacent to the top of the wall.

Photo 10 Left Spill Tube Structure, downstream asphalt overlay

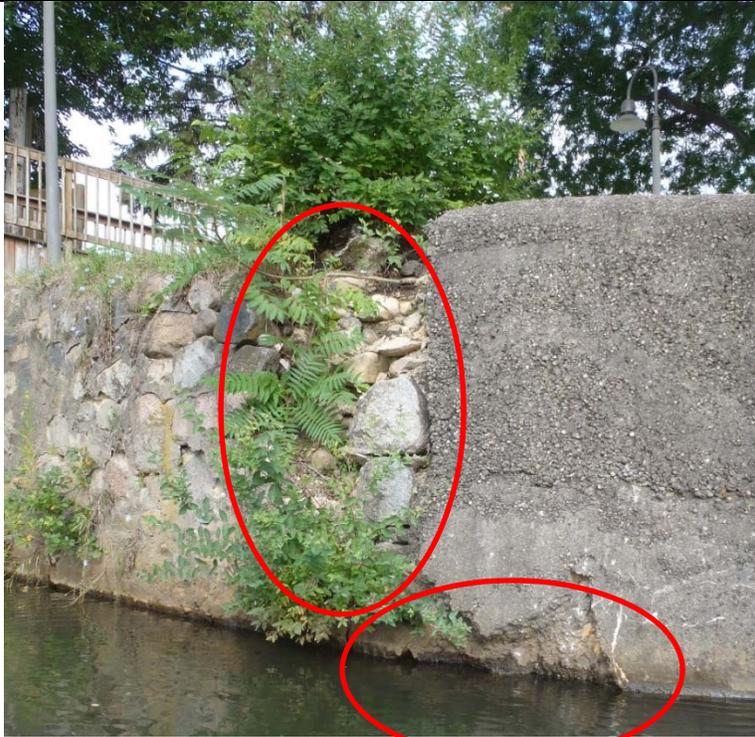
The cobblestone wall connects to a deteriorated concrete wall structure that extends downstream further than the rest of the spill tube structure. A portion of the deteriorated concrete wall fell on top of the lower portion of the wall approximately 20 years ago and still remains in place. Behind this wall is another concrete wall that was observed to be in better condition with some deterioration at the top (Photo 12). A camera was inserted into the void above this wall (below the top concrete slab). The area behind the wall was observed to be filled with sand and the void is completely filled with sand on the upstream side. The void area is approximately 3 feet wide and 1.5 feet tall, and extends approximately 5 feet upstream. The top slab was observed to be in good condition and the base of the slab appears to be poured on the sand fill. Hammer sounding on the top slab indicated the concrete was sound and was visually observed to be in good condition.

Photo 11 Left Spill Tube Structure, downstream wall deterioration

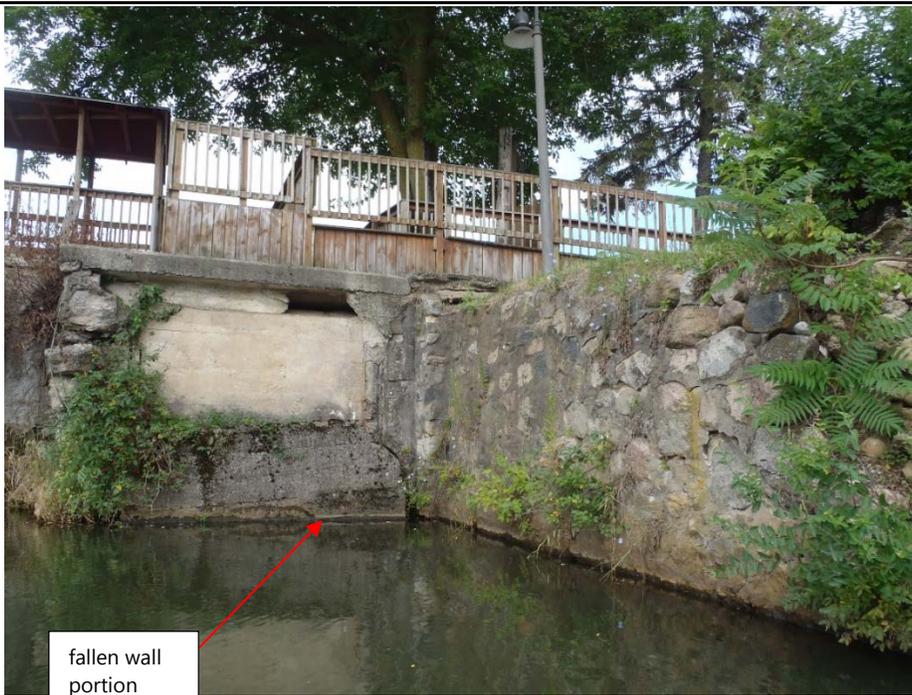
Photo 12 Left Spill Tube Structure, downstream wall and box structure

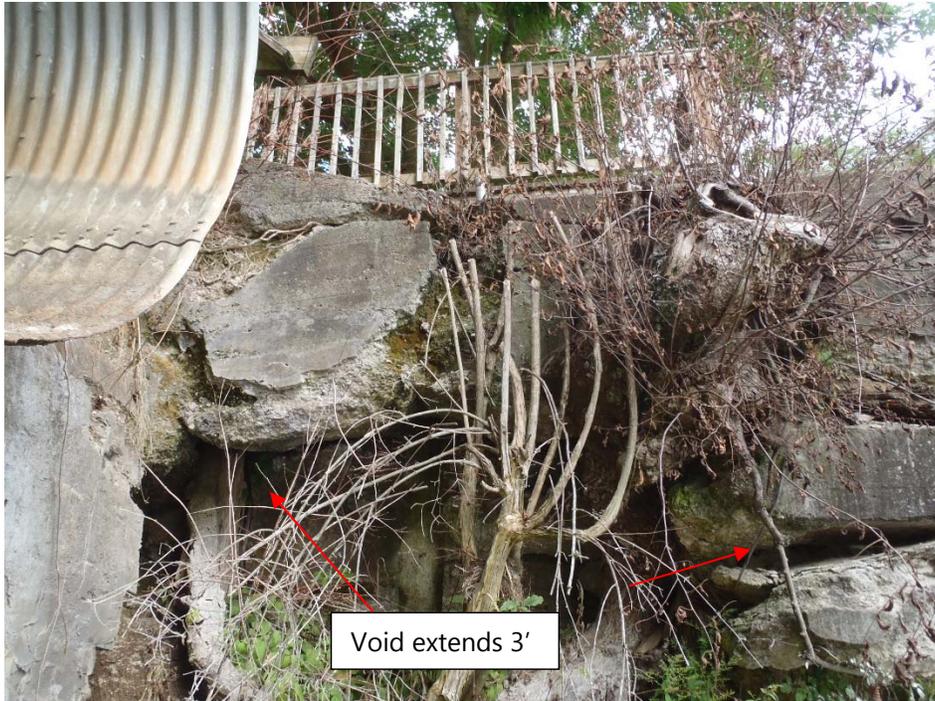
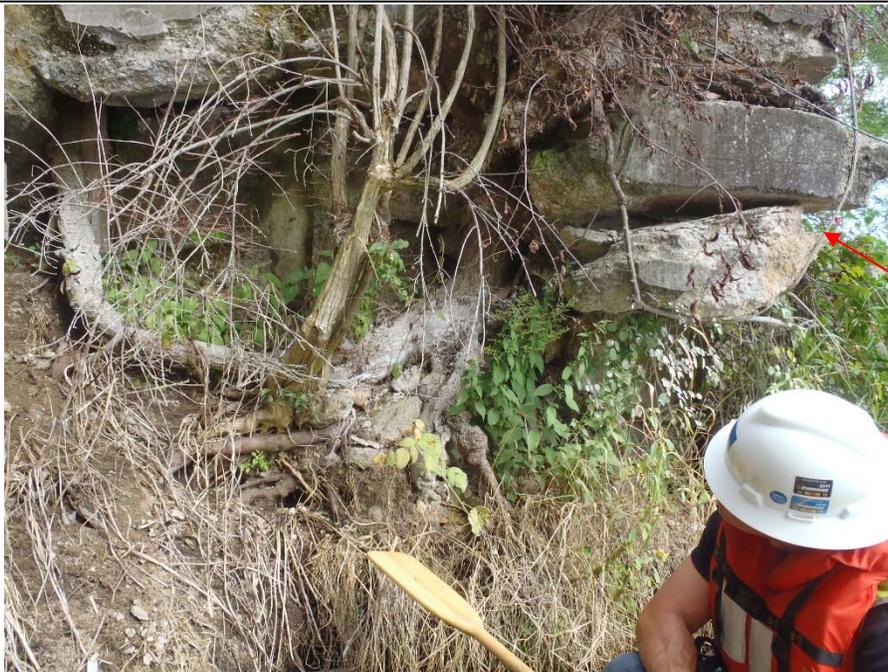
On the corner of the wall, multiple deteriorated concrete sections are held together with two separate pieces of wire rope (Photo 13 and Photo 14). Also, tree roots and vegetation is growing in this area. There is significant concrete deterioration and it is unclear that the concrete slab above is adequately supported from below. In the corner adjacent to the spill tube structure, deterioration was noted that extended approximately 4 feet tall, 3 feet deep (in the upstream direction) and 4 feet wide (left to right). The deterioration was measured from the edge of the downstream face of the concrete surrounding the spill tube to the closest soil or concrete structure encountered in the other directions.

Photo 13 Spill Tube Structure, deteriorated box structure with arrow pointing to wire rope

Photo 14 Spill Tube Structure, arrow pointing to wire rope

Existing structure is in poor condition and repair of the existing structure is unlikely to result in a 30-year fix. We recommend replacing the structure. It may be possible to stabilize the structure by building a buttress downstream but is unlikely to create a structure that will last for 30 years.

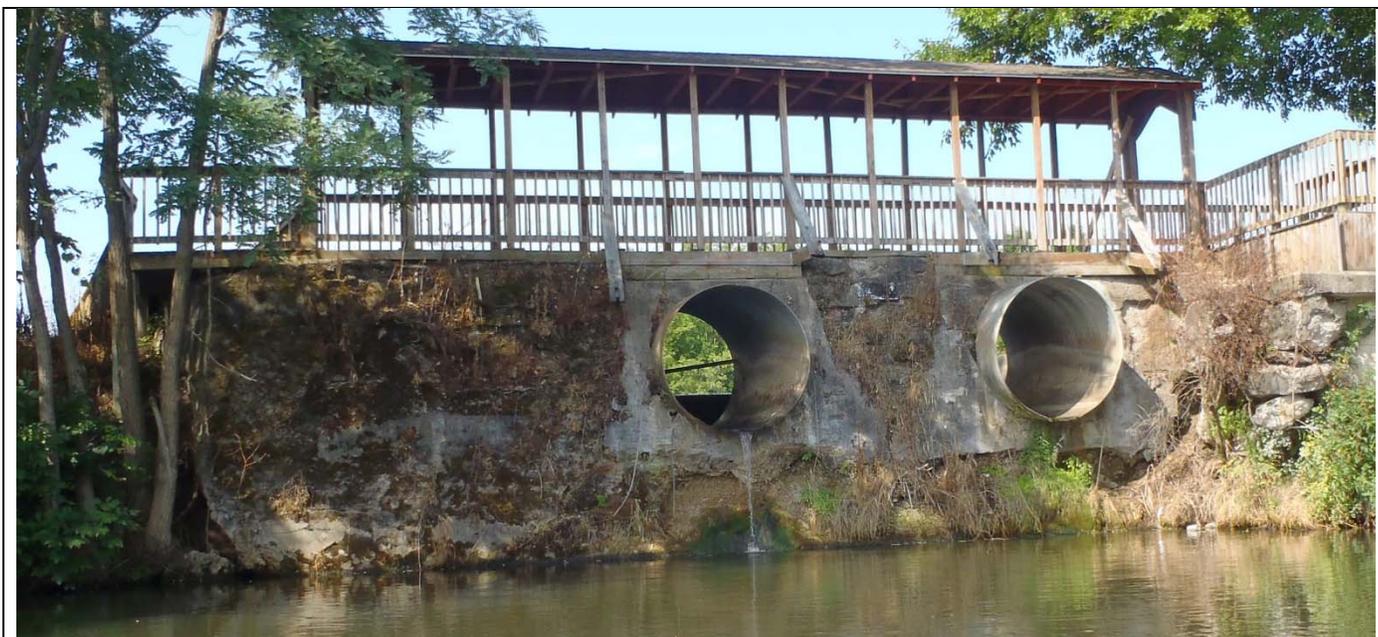
The angled downstream wall that surrounds the spill tubes appeared to be an older concrete structure with horizontal lift joints or blocks that was overlaid with a grout mixture (Photo 15). The grout overlay was deteriorated and in many locations missing, leaving the older concrete visible. The patch that was still intact appeared to be delaminated and below the spill tubes crumbled when hit with a hammer. The right side of the wall is covered in moss which indicates moisture in the area. John indicated the patch placed on the spill tubes was installed more than 30 years ago.

Photo 15 Spill Tube Structure, downstream

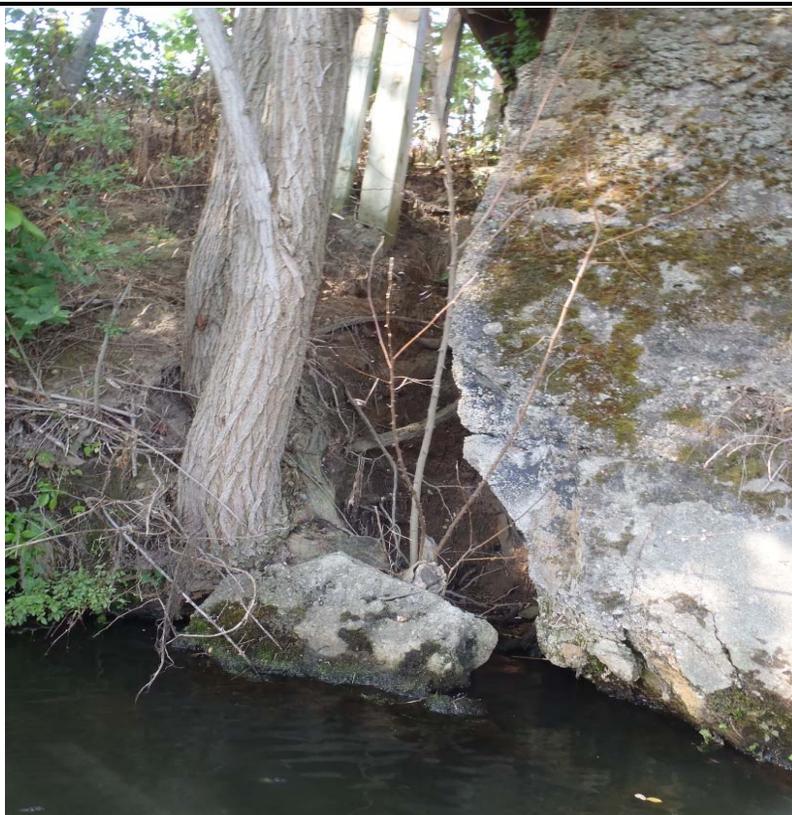
On the right side of the spill tube structure there was a gap between the edge of the concrete structure and the adjacent soil of the earth embankment (Photo 16). Concrete deterioration was evident on the edge and a portion of concrete that was falling apart was visible above the water surface. The soil gap was measured for approximately 10 feet high above the water level, extending approximately 6-8 feet deep (upstream) and between 1 to 3 feet wide (left to right). John indicated this erosion has occurred over time and not during high flow events or overland flow. He has not remembered finding wet soil in that area in the past.

Photo 16 Gap between right edge of spill tube structure and right embankment soil

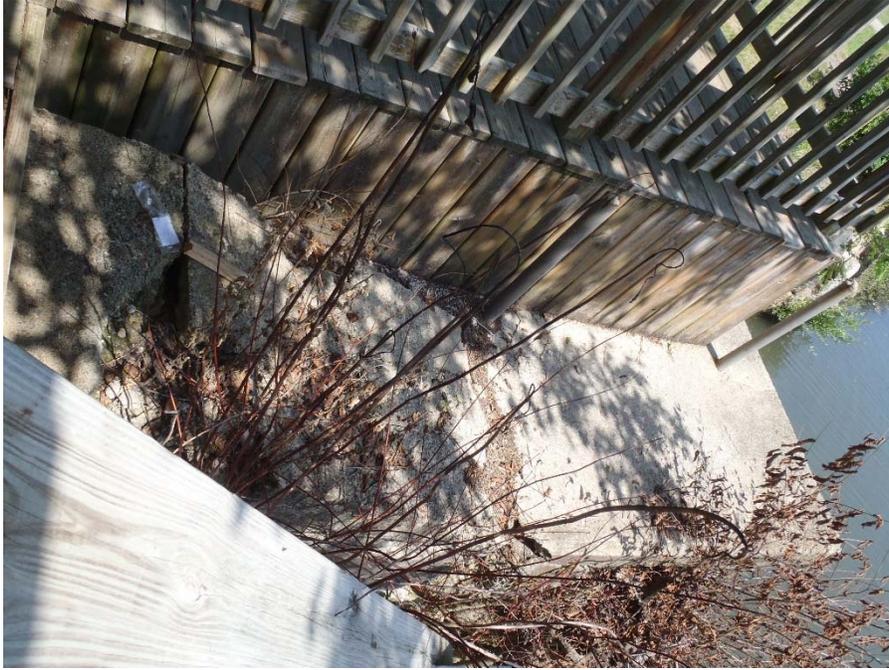
The slab above the box structure has some cracks and deterioration (Photo 17). Accessible areas that were sounded with a hammer were observed to have intact concrete.

Photo 17 Downstream Box Structure top view

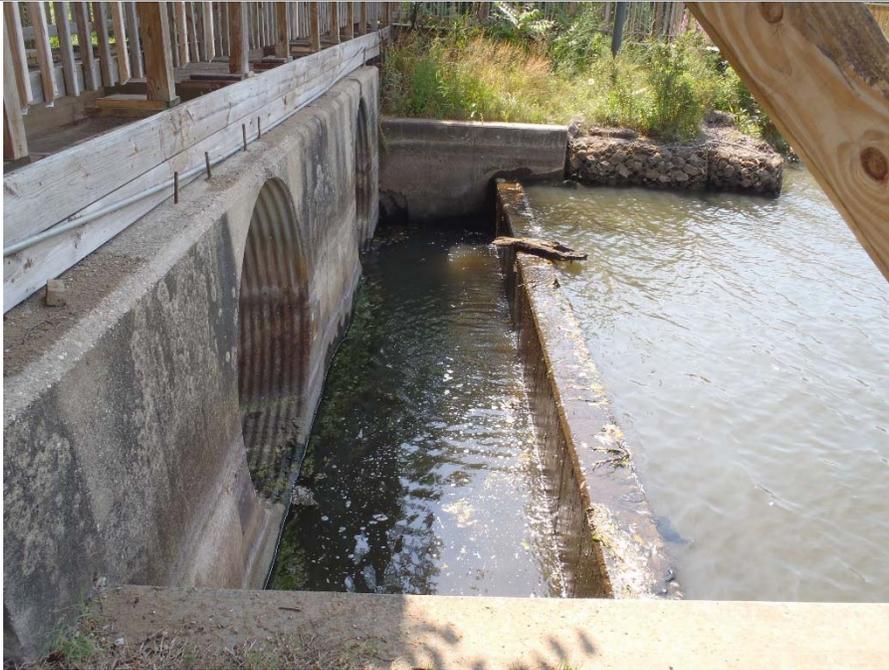
Photo 18 Upstream Spill Tube Structure Weir

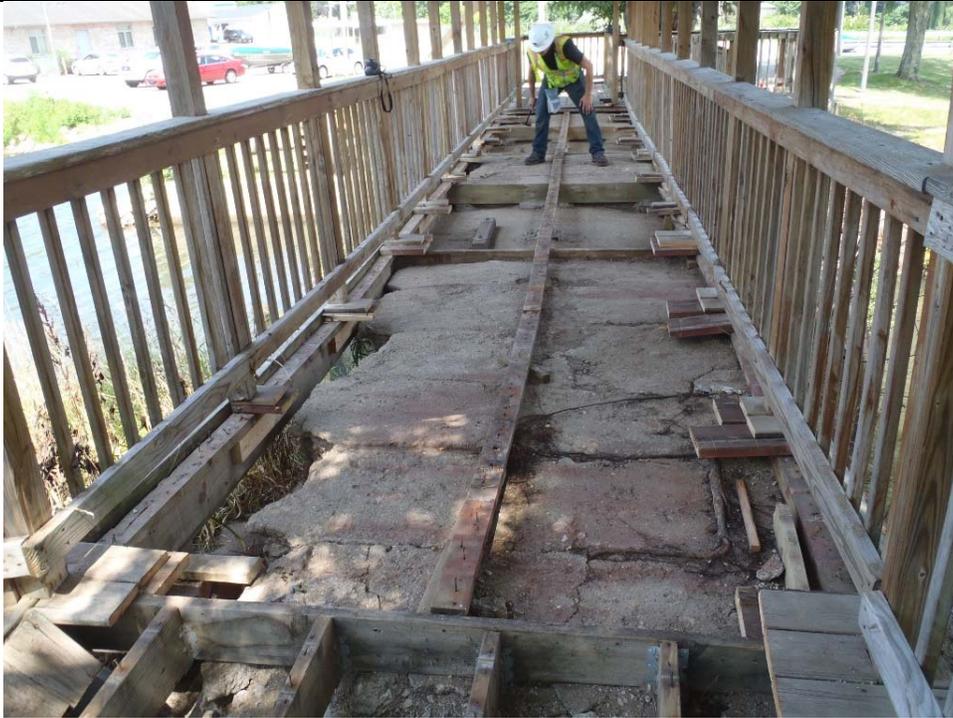
The upstream face of the spill tube structure appears to be an overlay approximately 14 inches thick and extending upstream from what was believed to be the original structure. The concrete downstream of that overlay was in significantly worse condition with the worst concrete on the right side of the structure (when looking downstream) (Photo 19).

Photo 19 Spill Tube Structure top view

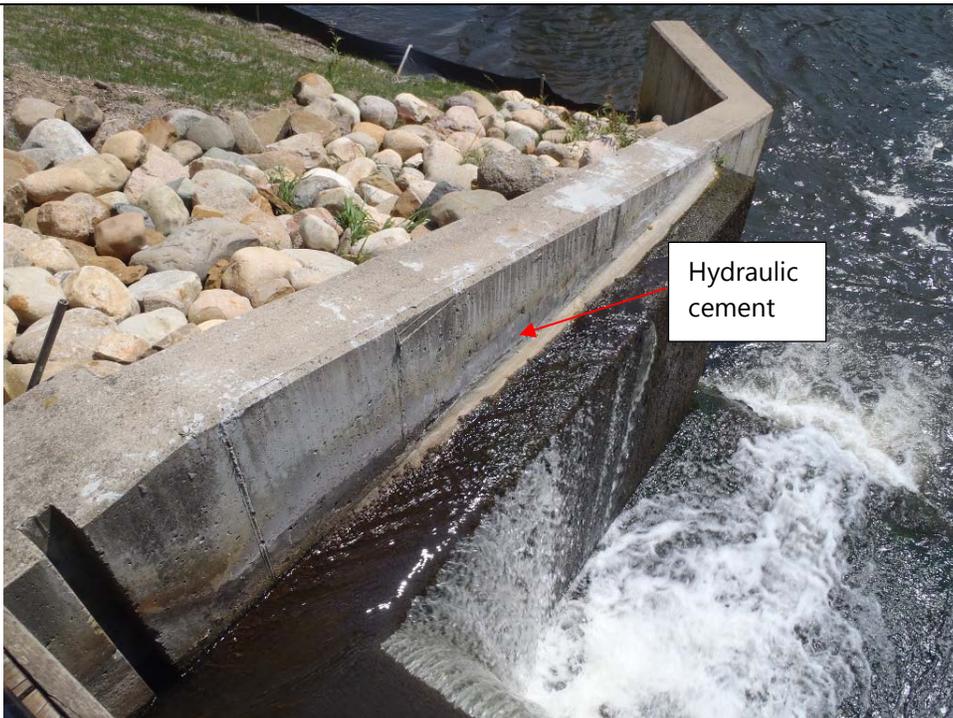
Photo 20 Control Structure and Earth Embankment
