MAPLE LAKE IMPROVEMENT MANAGEMENT PLAN STUDY

Village of Paw Paw and Paw Paw Township
Van Buren County, Michigan

**A LAKE MANAGEMENT PLAN AND STUDY FOR
MAPLE LAKE, VAN BUREN COUNTY, MICHIGAN**

OCTOBER, 2009

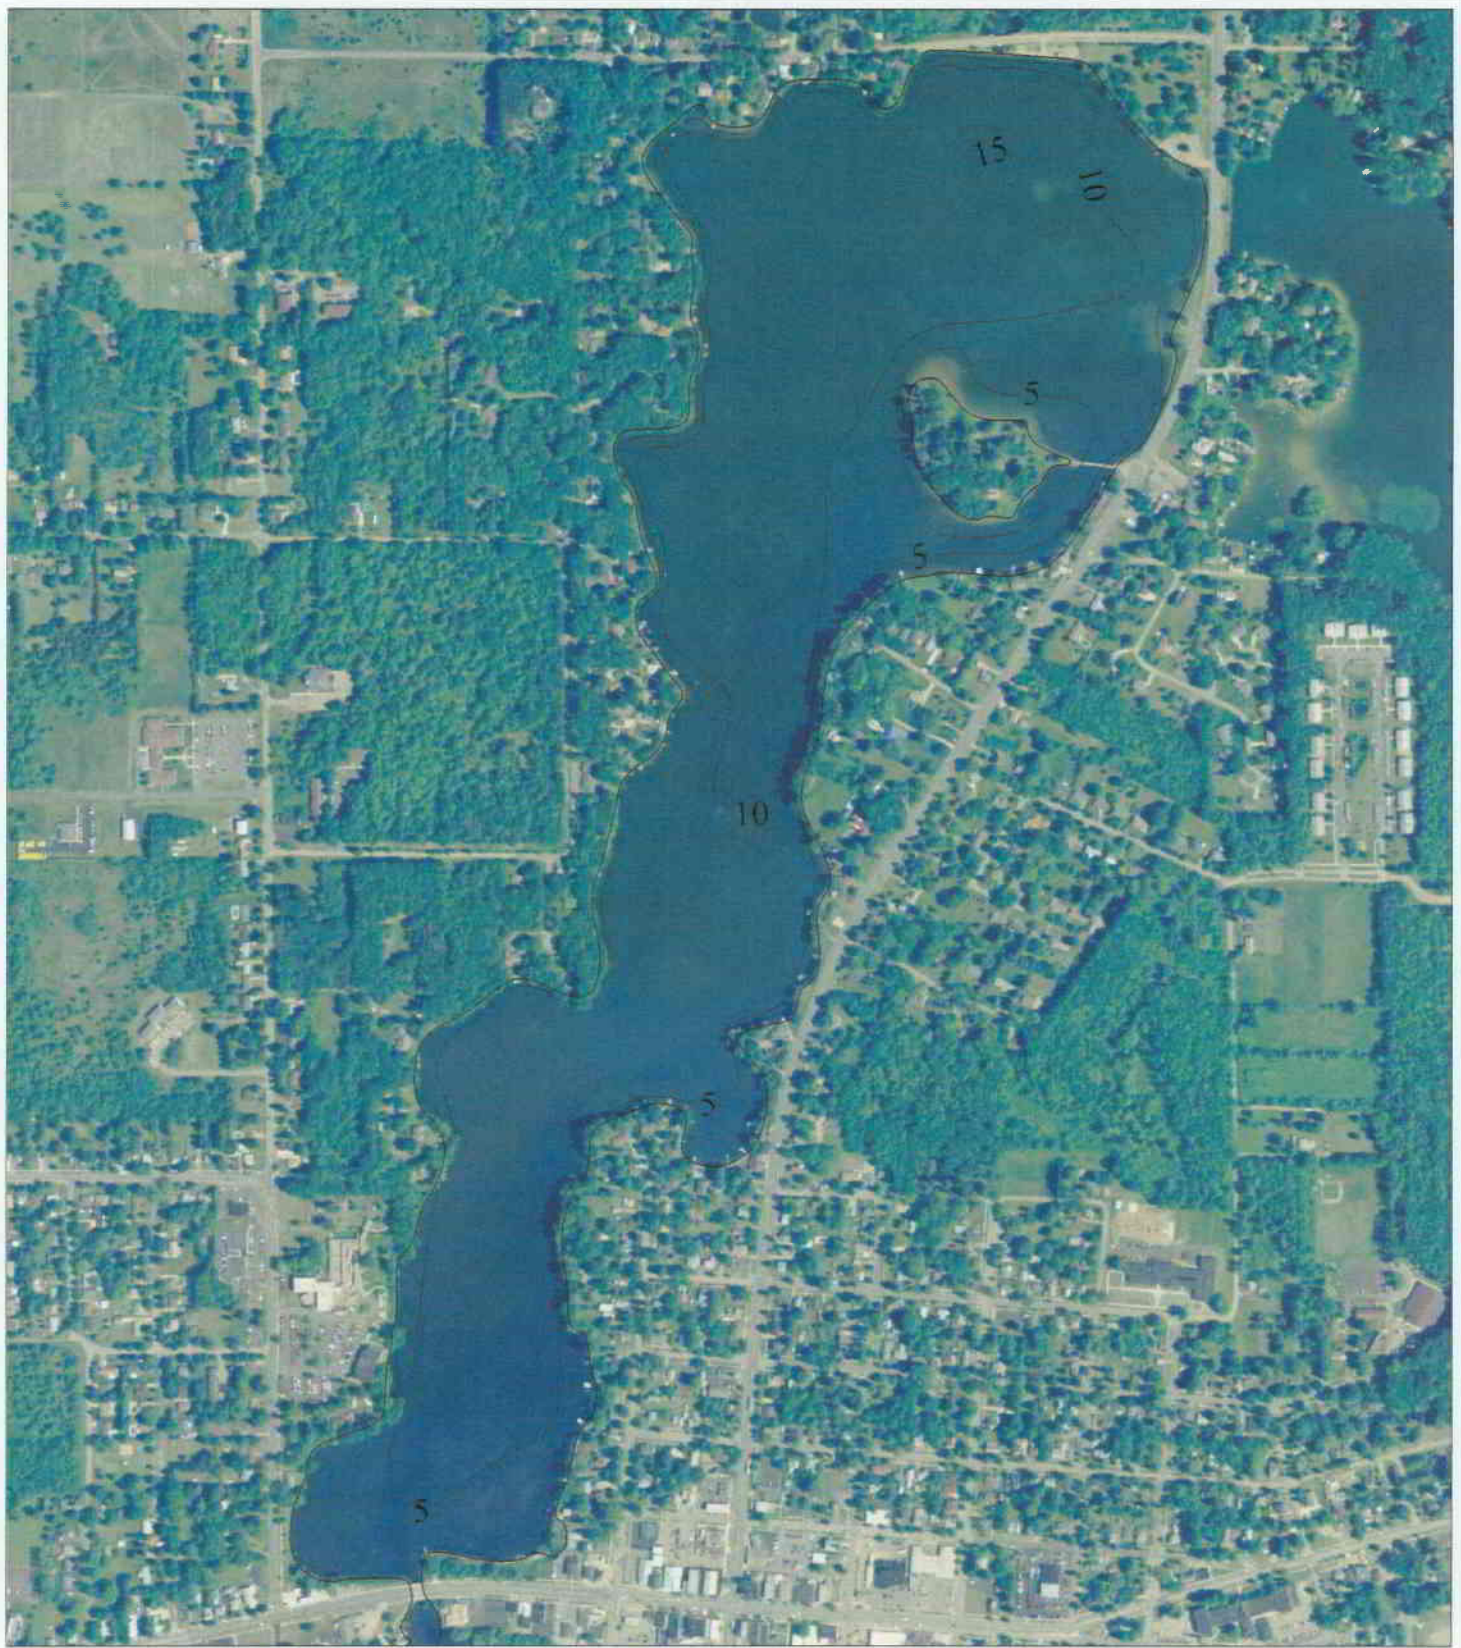
FIGURE 1

SCALE: 1 INCH = 800 FEET

Maple Lake is located in sections 1, 11, 12, 13, and 14 (T.3S, R.14W) of the Village of Paw Paw and Paw Paw Township, Van Buren County, Michigan (Figure 1). The lake surface area is approximately 172 acres (Michigan Department of Natural Resources, 2001) and may be classified as a eutrophic lake with one deep basin and a large-sized littoral zone. Maple Lake has a maximum depth of 15.0 feet (Figure 2), and an average depth of 7.0 feet (MDNR, 2005). The lake bottom consists primarily of sandy substrate and organic matter deposits.

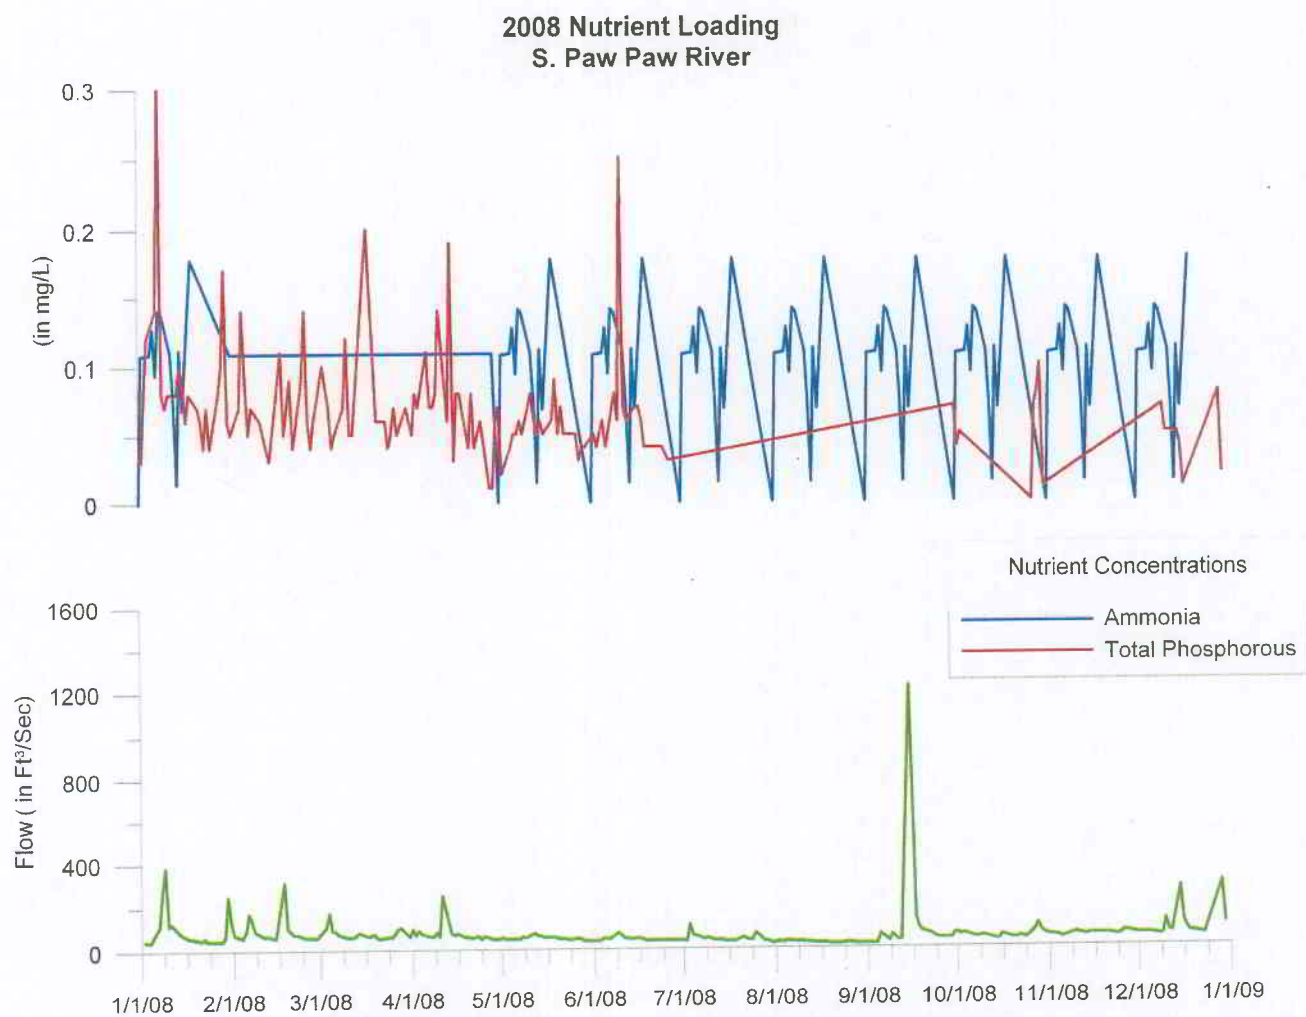
Figure 7. Annual contributions of the nutrients total phosphorus and ammonia nitrogen to Maple Lake by the South Branch of the Paw Paw River in 2008.

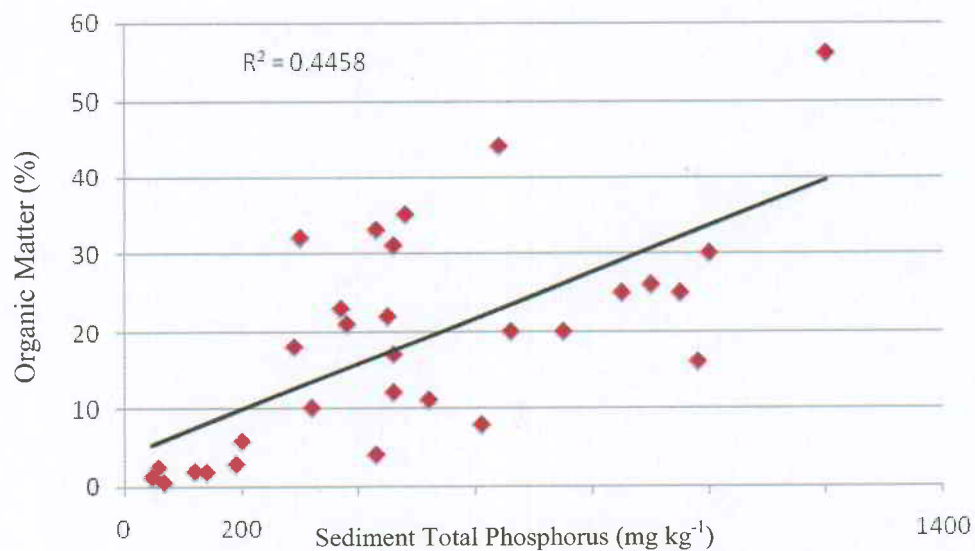
Figure 8. Correlation graph of % organic matter and sediment total phosphorus in Maple Lake sediment samples ($n = 30$)

The amount of organic carbon in lake sediments contributes greatly to the growth of rooted aquatic plants which depend on the sediments for nutrients such as phosphorus and nitrogen. Lake bottom sediment samples were collected at the Maple Lake sampling locations with the use of a stainless steel hand auger. The upper horizons of the sediment were kept intact for accurate evaluation of organic matter content in the upper layers. Samples were placed on ice and taken to a certified laboratory for analysis of sediment total phosphorus and percentage of organic matter. The percentage of fine sediments was determined through a sieve analysis (No. 200 standard sieve, 74 μm mesh size), after sediments were dried in a muffle furnace at 550°F. Sediment total phosphorus concentrations ranged from 47.0 mg kg^{-1} – 1,000 mg kg^{-1} , with the highest values present at the south and south-central basin near the primary inlet. Organic matter content ranged from 1.2% - 56.0% with the highest values also present at the south and south-central basin. There was a substantial positive linear correlation ($R^2 = 0.44$) between organic matter content and sediment total phosphorus (Figure 8). The percentage of fine sediment among samples ranged from 1.4% - 58.8%, and was weakly correlated with sediment total phosphorus ($R^2 = 0.24$; Figure 9) and sediment organic matter content ($R^2 = 0.25$; Figure 10).

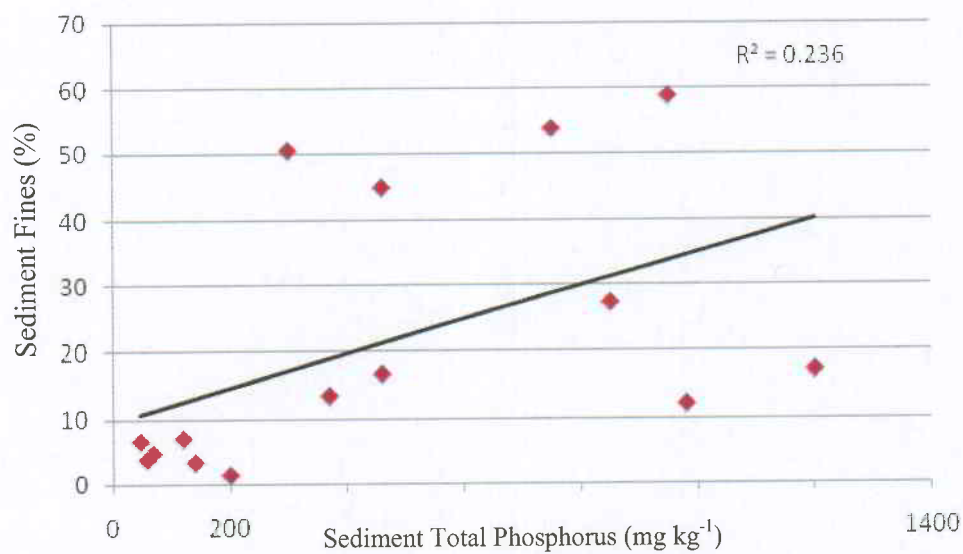
Figure 9. Correlation graph of % sediment fines and sediment total phosphorus in Maple Lake sediment samples ($n = 15$).

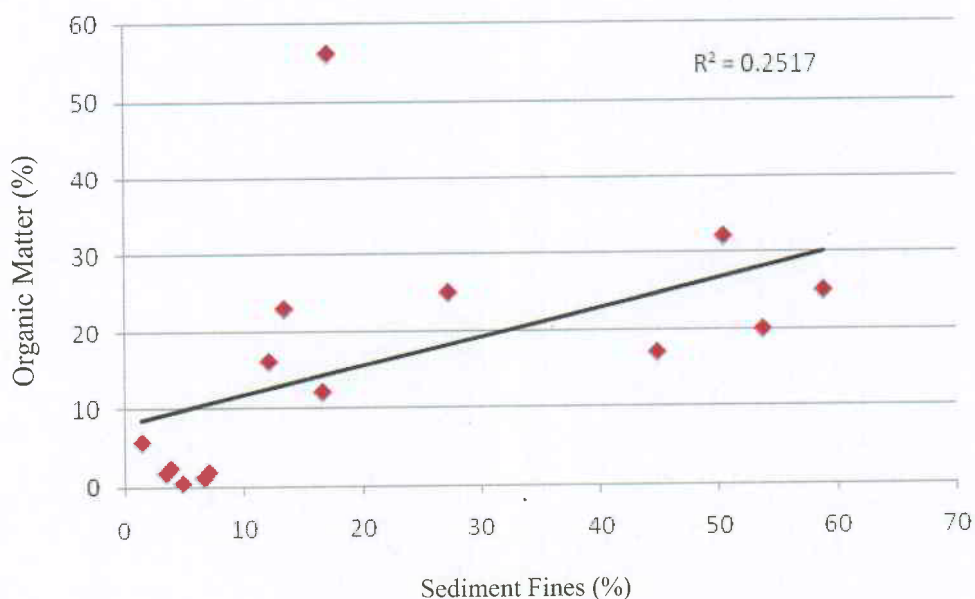
Figure 10. Correlation graph of % organic matter and % sediment fines in Maple Lake sediment samples (n = 15).

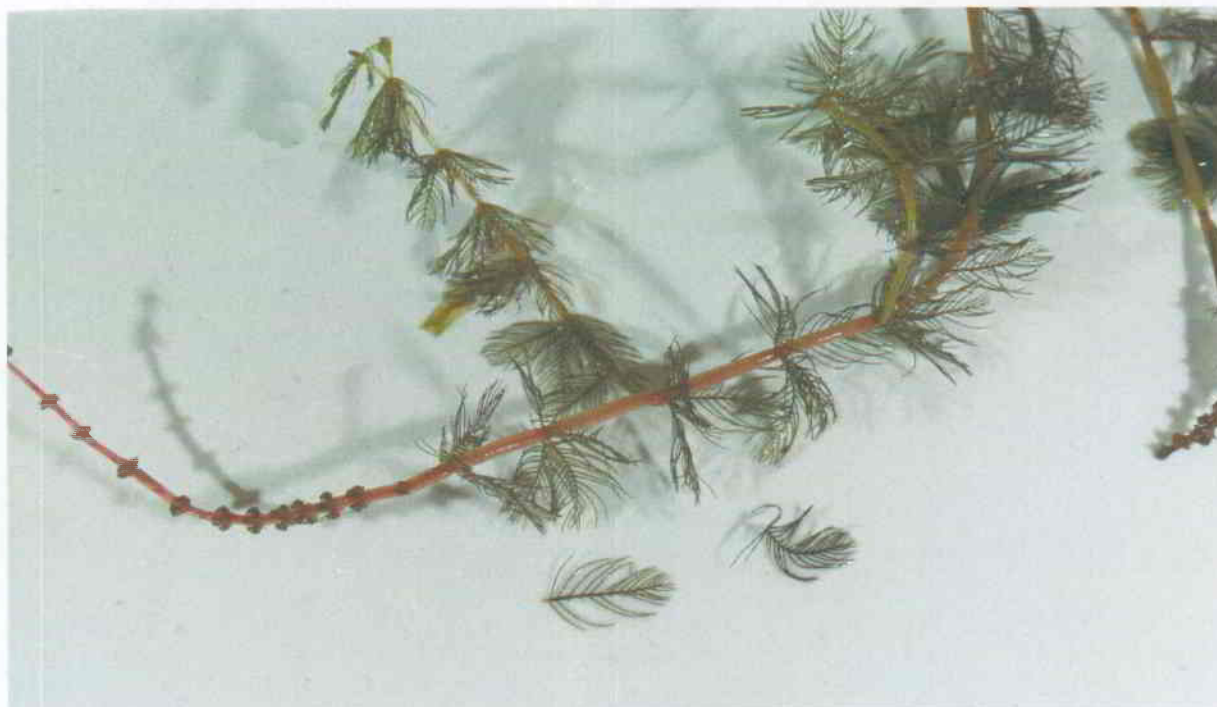
Figure 11. A photograph showing the seed structures (a), dissected leaves (b), and lateral branches (c) of (pure strain) Eurasian Watermilfoil (*Myriophyllum spicatum*).

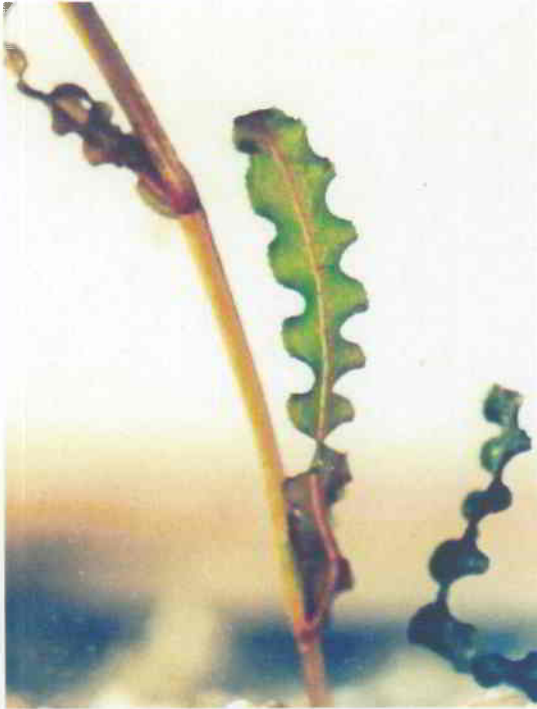
Figure 12. A photograph showing the stem and leaf portion of Curly-leaf Pondweed (*Potamogeton crispus*)

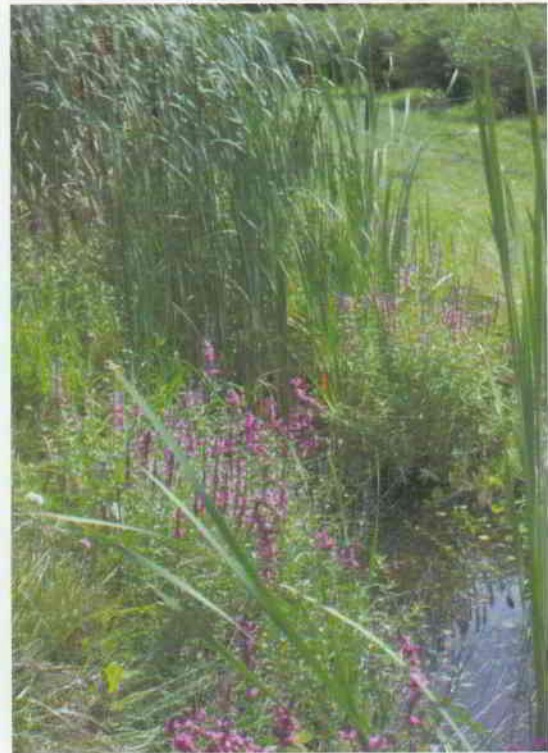
Figure 13. A photograph of Purple Loosestrife (*Lythrum salicaria*) in a drainage basin

<i>Exotic Aquatic Plant Species</i>	<i>Common Name</i>	<i>Growth Habit</i>	<i>Abundance in or around Maple Lake</i>
<i>Myriophyllum spicatum</i> , 1	Eurasian Watermilfoil	Submersed; Rooted	Common/Dense
<i>Potamogeton crispus</i> , 2	Curly-Leaf Pondweed	Submersed; Rooted	Common/Dense
<i>Lythrum salicaria</i> , 43	Purple Loosestrife	Emergent	Sparse

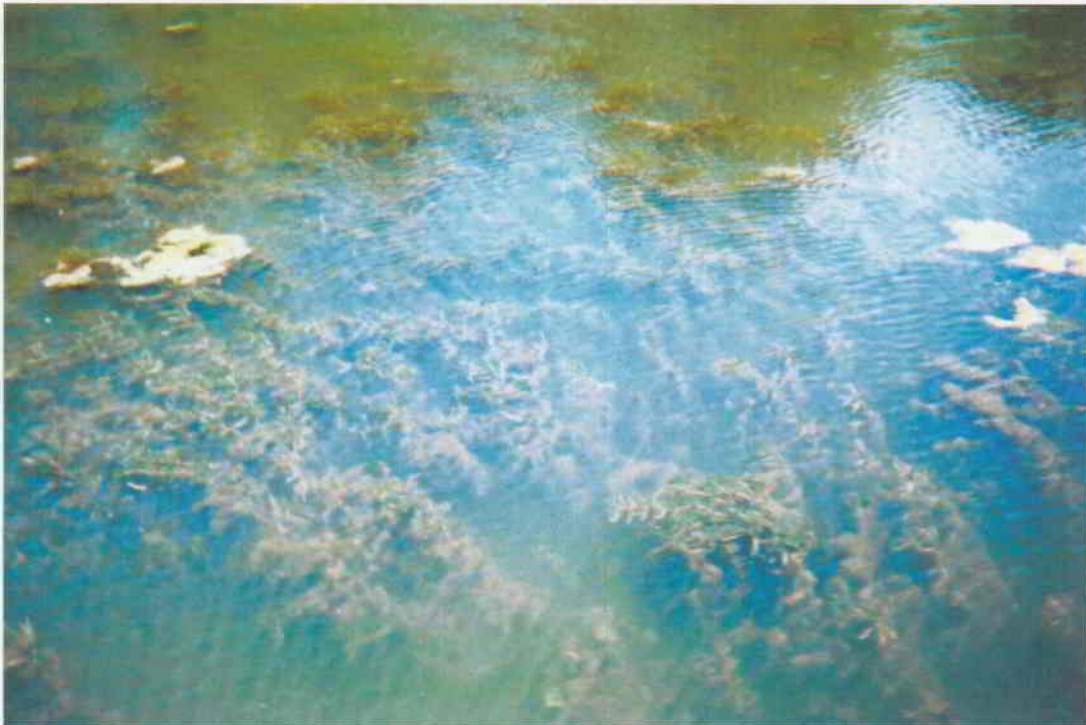
Figure 14. A canopy of Curly-Leaf Pondweed on Maple Lake (September, 2009).

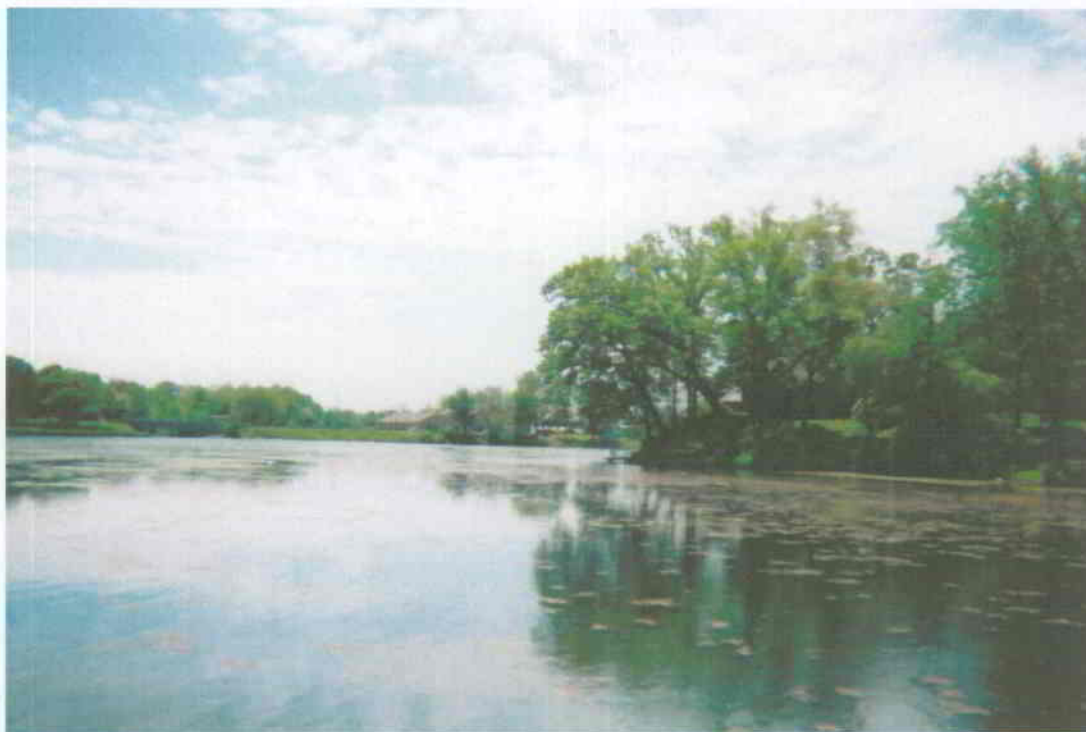
Figure 15. Abundant filamentous algae on the surface of Maple Lake (September, 2009).

Some individual plants of *M. spicatum* were found at depths of approximately 10 feet; however, the majority of the growth was located at depths between 5-10 feet. *M. spicatum* growth is thus capable of growing in most of the littoral zone of Maple Lake. *M. spicatum* growth in Maple Lake is quite robust, with wide, thick stems, capable of producing dense surface canopies. The results of detailed GPS-guided aquatic vegetation (AVAS) survey of Maple Lake on 1 September, 2009 demonstrated that approximately 50 acres of pure *M. spicatum* infested the lake. It is imperative that lakes which are in close proximity to Maple Lake also adopt sound lake management strategies with respect to exotic species control to prevent the spread of exotic species such as *M. spicatum* which are a constant threat to the ecological balance of the Maple Lake ecosystem. The submersed aquatic exotic plant, Curly-leaf Pondweed (*Potamogeton crispus*; Figure 12), was also found in abundant quantities throughout the lake. It is susceptible to natural deterioration by early July and does not fragment; however, it produces robust seed pods called turions that overwinter in the seed bank. Thus, management of the plant should include removal via the use of mechanical or chemical methods before this turion is seasonally formed. In addition to *M. spicatum*, Maple Lake contained ample quantities of the emergent exotic Purple Loosestrife (*Lythrum salicaria*; Figure 13), which appeared to be dying. Figure 14 shows a combination of *P. crispus* and filamentous algae on the lake. Excessive algal blooms on Maple Lake are shown in Figure 15.

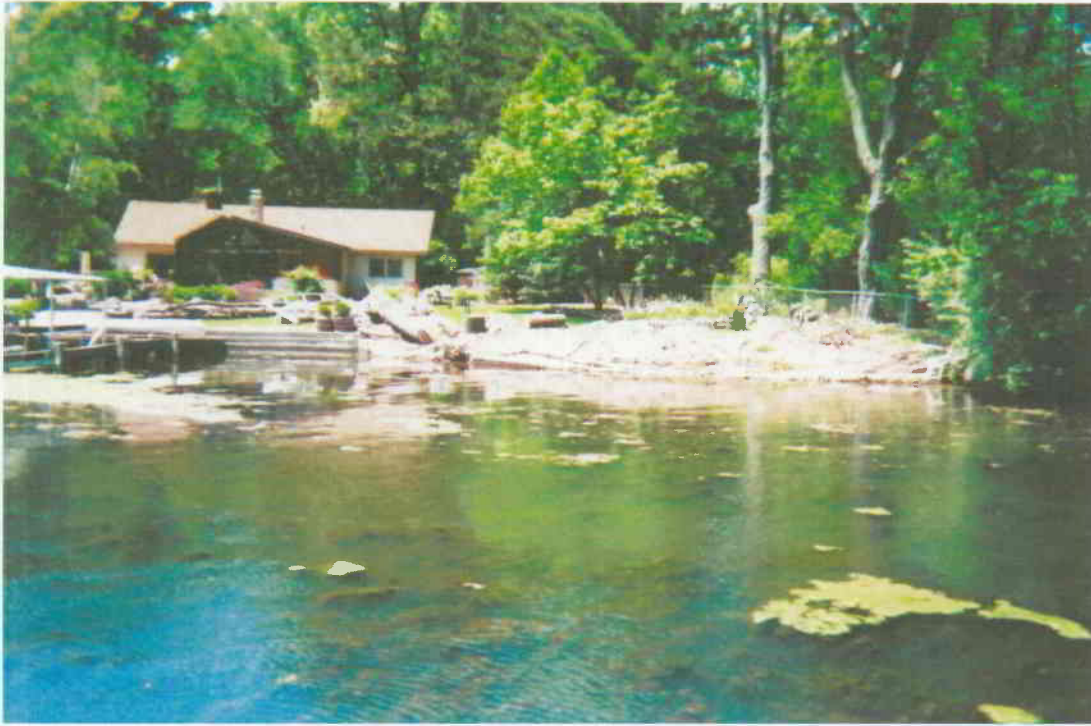
Figure 16. Erosion of sand into Maple Lake (September, 2009).

The construction of impervious surfaces (i.e. paved roads and walkways, houses) should be minimized and kept at least 100 feet from the lakefront shoreline to reduce surface runoff potential. In addition, any wetland areas around Maple Lake should be preserved to act as a filter of nutrients from the land and to provide valuable wildlife habitat. Construction practices near the lakeshore should minimize the chances for erosion and sedimentation by keeping land areas adjacent to the water stabilized with rock, vegetation, or wood retaining walls. Increased erosion may lead to increased turbidity and nutrient loading to the lake (Figure 16). Seawalls should consist of rip-rap (stone, rock), rather than metal, due to the fact that rip-rap offers a more favorable habitat for lakeshore organisms, which are critical to the ecological balance of the lake ecosystem. If metal seawalls are currently used, then rip-rap should be installed in front of the seawall and extend into the water to create the presence of microhabitats for enhanced biodiversity of the aquatic organisms within Maple Lake. The emergent aquatic plant, *Scirpus* sp. (Bulrushes) offers satisfactory stabilization of shoreline sediments and assists in the minimization of sediment release into the lake.

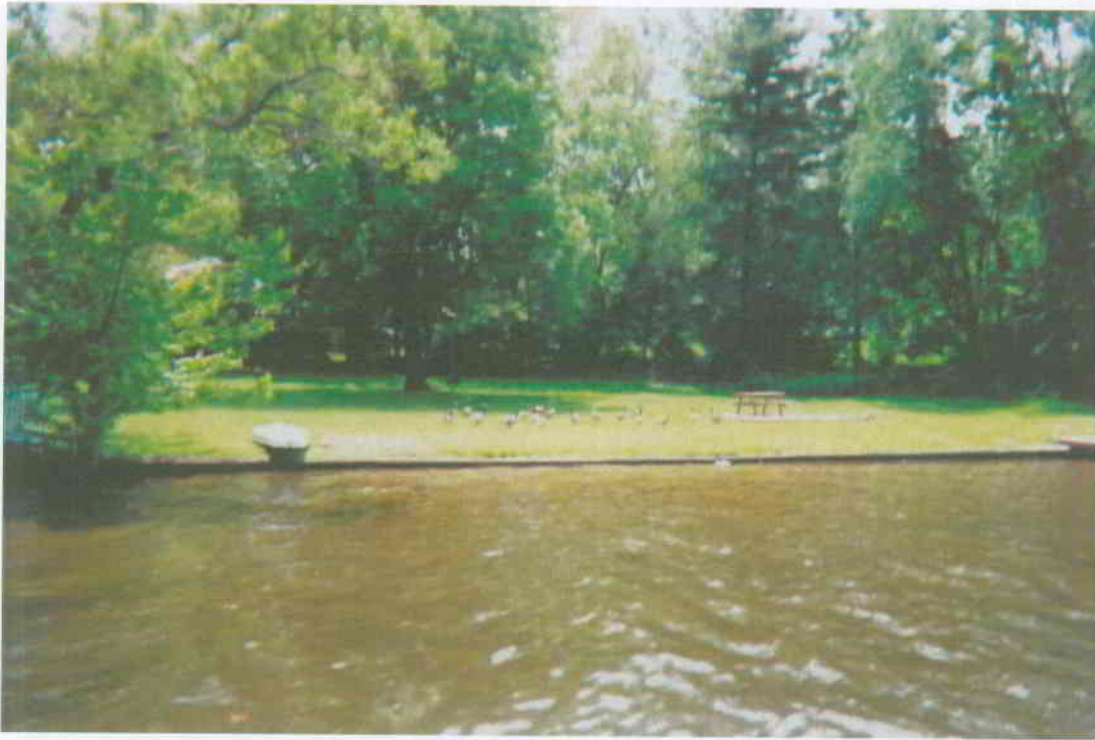
Figure 17. Geese gathering on Maple Island (September, 2009).

In addition to the contribution of *E. coli* from runoff sources, waterfowl populations should also be controlled since they may contribute bacteria and nutrients to the lake and also contribute to the problem of swimmer’s itch. This is especially important in areas of Maple Lake where the soils are prone to ponding or saturation (i.e. the mucks). Such ponding could cause an overflow of *E. coli* directly into the lake during a strong runoff event. It is recommended that the residents of Maple Lake prevent the feeding of waterfowl that visit lakefront properties. In addition, since many of the geese were found on Maple Island (Figure 17), it is strongly recommended that a thick riparian vegetation buffer be placed around the perimeter of the island to deter geese and reduce their presence. Waterfowl populations may be controlled by following these guidelines:
